SEAWORLD ORLANDO LIGHTNING INCIDENT

**FAILURE OF THE SECOND GENERATION
EARLY STREAMER EMISSION LIGHTNING ROD**

**By
Z. A. Hartono & I Robiah
September 2012
E-mail: zahartono@ieee.org**

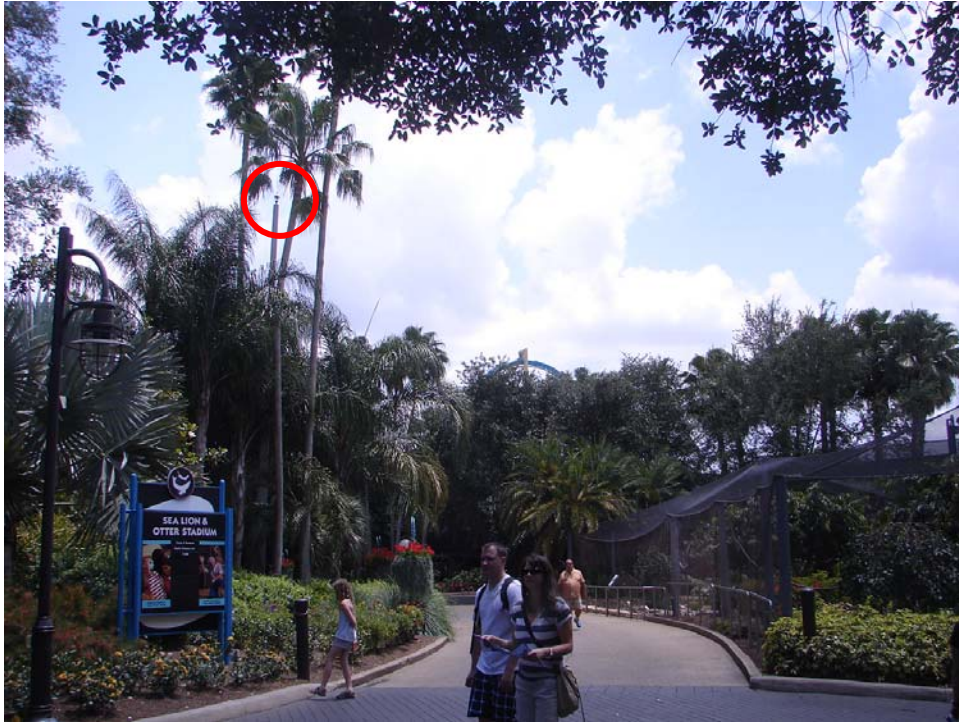
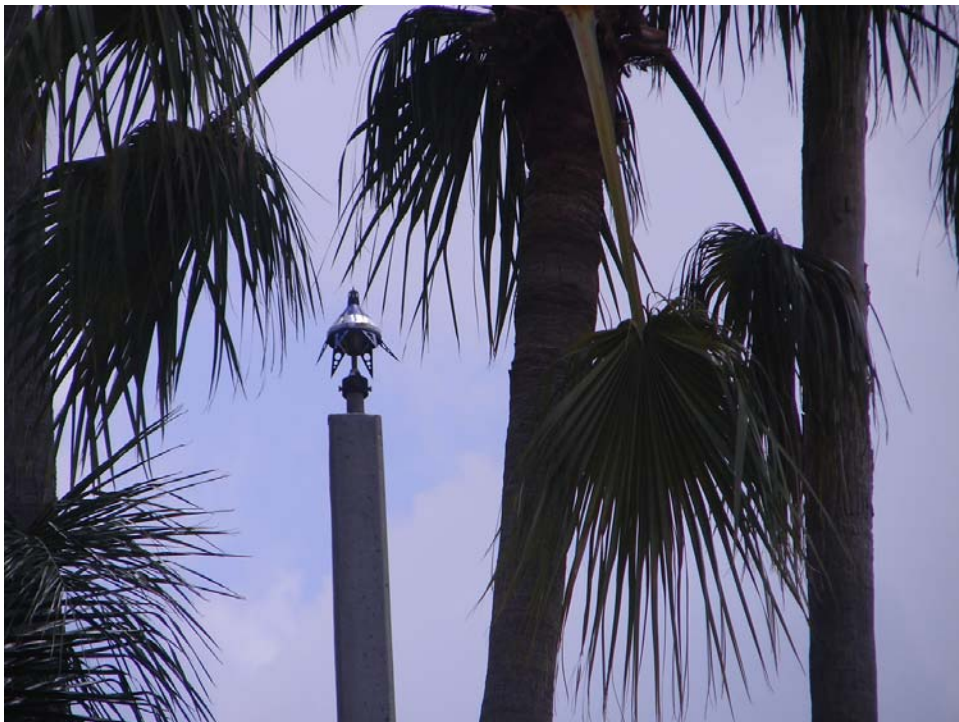
Fig. 6a: Shark Encounter.

Fig. 6b: Close-up photograph of the Preactron 2 Millennium S 6.60 lightning rod mounted on top of an approximately 15 m high concrete pole.

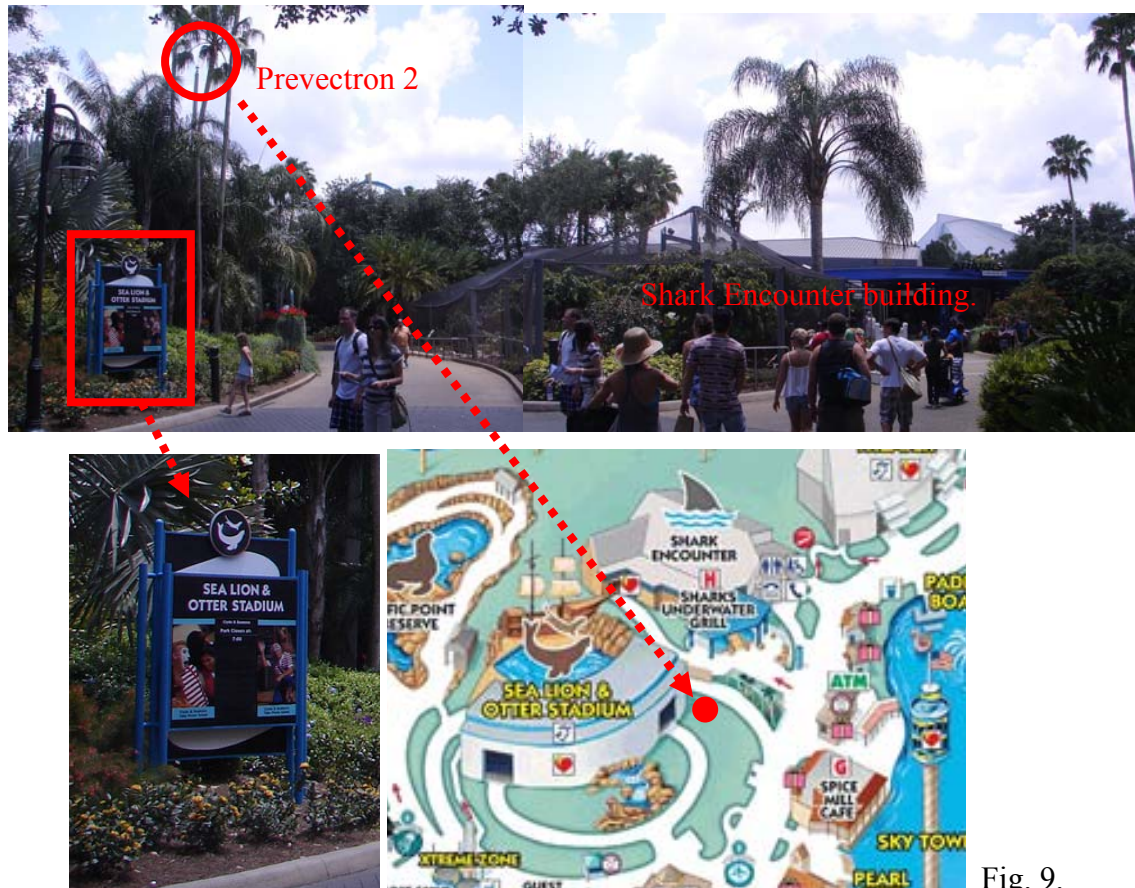
Fig. 9.

The Shark Encounter exhibit is located inside a building which is adjacent to the Sea Lion and Otter Stadium. The Prevector 2 lightning rod is mounted on an estimated 15 m high concrete pole which is located besides a footpath that runs in between both buildings (Fig. 9).

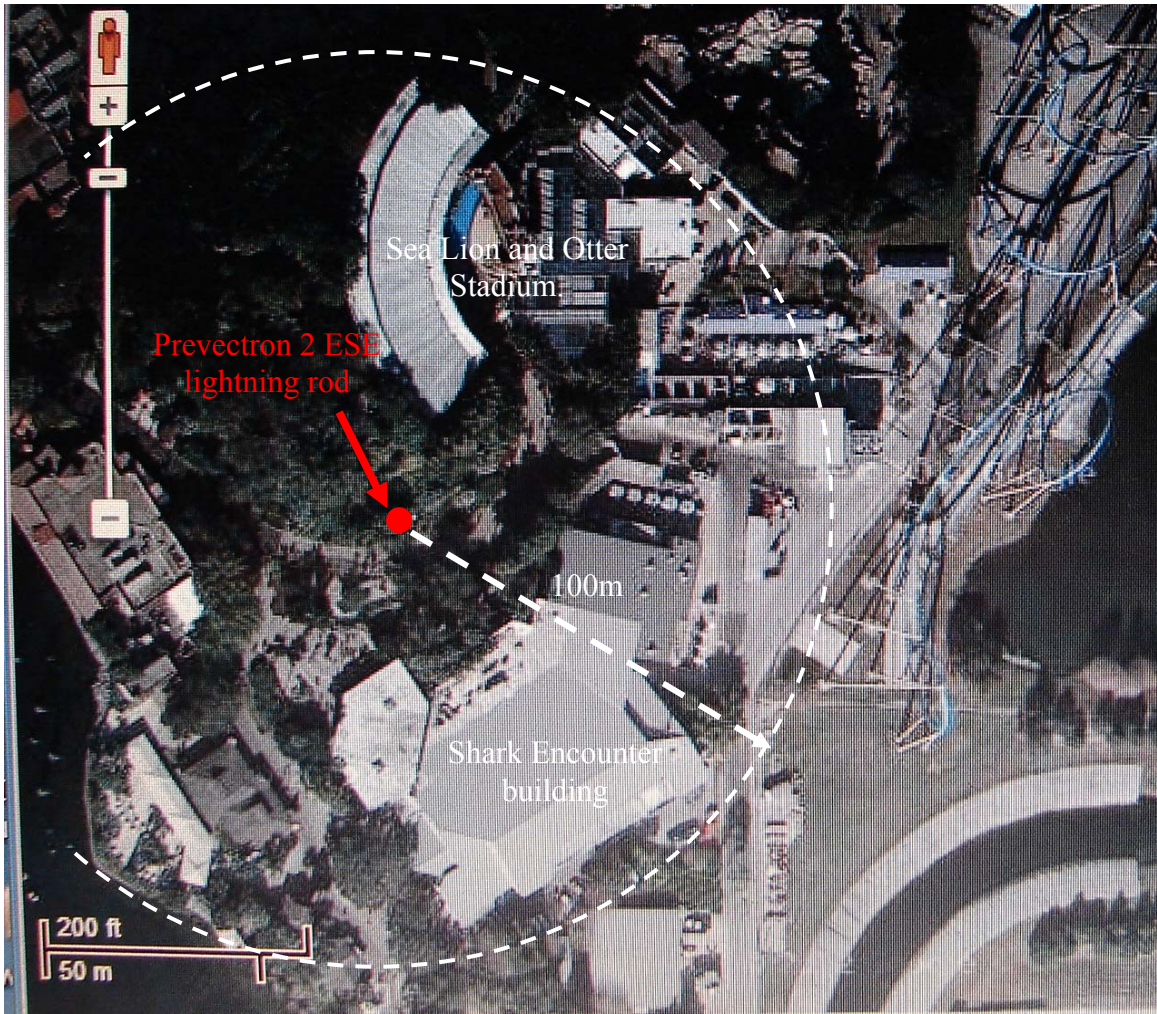
Using Google Map Satellite View, both the Shark Encounter building and the Sea Lion and Otter Stadium were found to be located well within 100 m of the Prevector 2 ESE lightning rod (Fig. 10). According to the Indelec website, a 5 m clearance above the surface to be protected will enable the Prevector 2 to provide a 107 m radius protection zone. This puts both buildings within the Prevector 2 claimed zone of protection.

In July 2012, a guest to the theme park received a shock while she was inside the Shark Encounter exhibit during a thunderstorm. The building's metal roof was struck by lightning and fortunately, the guest only suffered a minor injury as a result of the indirect lightning strike.

Fig. 10: The location and claimed protection zone of the Prevectron 2 ESE lightning rod (Satellite view source: Google Map).
