ICLP 2000

A STUDY OF NON-CONVENTIONAL AIR TERMINALS AND STRICKEN POINTS IN A HIGH THUNDERSTORM REGION.

Z. A. Hartono
hartono@pc.jaring.my
Lightning Research
Malaysia

Abstract: The widespread use of the non-conventional air terminals in Malaysia, in particular the Early Streamer Emission (ESE) type, has resulted in many buildings being struck by lightning. The study includes the various types of ESE air terminal that was widely used on new buildings in the 1990s. The study also reveals the pattern of lightning strikes on buildings of various shapes and sizes. This can lead to improved methods of protecting selected parts of buildings from the damaging effects of lightning and the prevention of lightning strikes on roof mounted equipment.

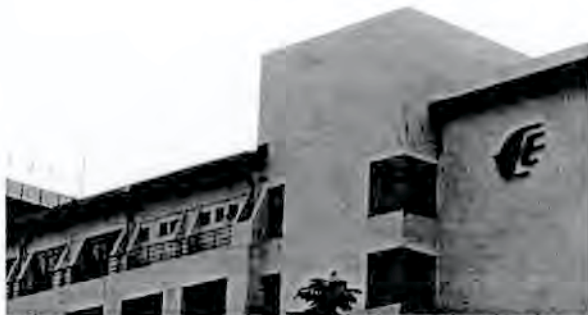
This case study was conducted on a training academy of Malaysia Airline, the national carrier company. The building measures approximately 20m high, 20m wide and 45m long and was expected to be struck by lightning at the rate of once in every two years. A single ESE air terminal was installed on the roof of the building located near the center of the building (Figure 1).

A photograph of the new building was taken in 1995 that show the air terminal and the yet-to-be damaged building part that was identified as having a high probability of being struck by lightning. Another photograph was taken in 1999 when the stricken point was observed, indicating a lightning strike had occurred (Figure 2). Another stricken point was observed to have occurred earlier at another part of the building.

Figure 1. A picture of the Malaysia Airline building taken in 1995 showing the ESE air terminal (left).

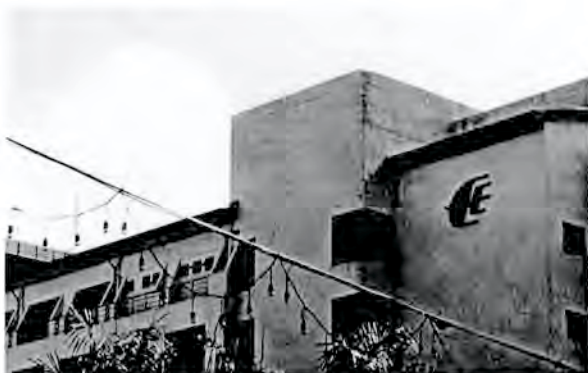
Figure 2. The same building photographed some years later showing the stricken point (top right).

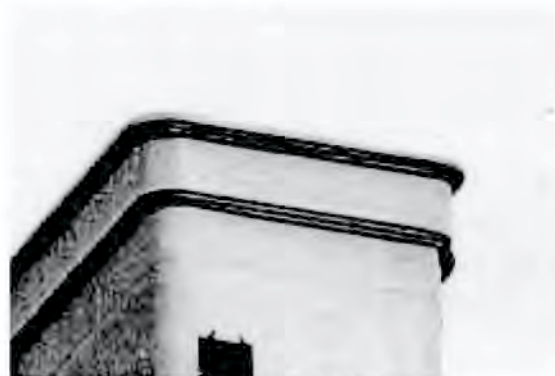
The building was completed in 1995 and installed with two ESE air terminals. The first stricken point was observed in 1996 followed by another in 1997. This was followed by a year long drought in 1998.

Figure 3. A photograph of the Villa Putra apartment taken in February 1999 showing the undamaged upper level roof. Two stricken points had been observed on two other lower level roofs.

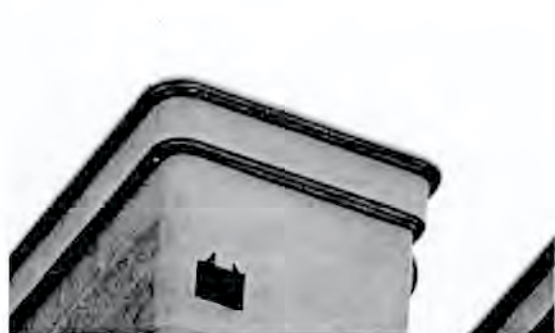
Five new stricken points were discovered during the second half of 1999 after a spate of intense thunderstorms that broke out from June to August (Figures 3 and 4).

Figure 4. The same building photographed six months later showing two (out of five) new stricken points.

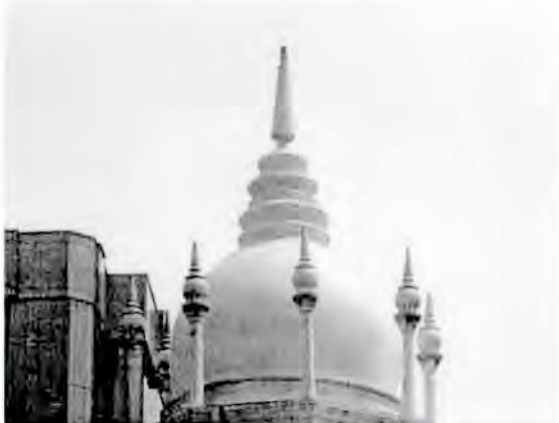
Most slim structures (such as spires, minarets, roof mounted emblems etc.) that were observed to have been struck by lightning exhibited stricken points that were below the pinnacle (Figure 5). This indicates that the air terminal installation for these structures must anticipate a strike to the entire structure and not just at the highest point only.

The shielding effect of a corona discharge on the pinnacle could offer one explanation for lightning discharges to strike the fabric below slim structures [4].

Figure 5. A lightning damaged spire on top of a dome. Note the stricken point below the pinnacle.

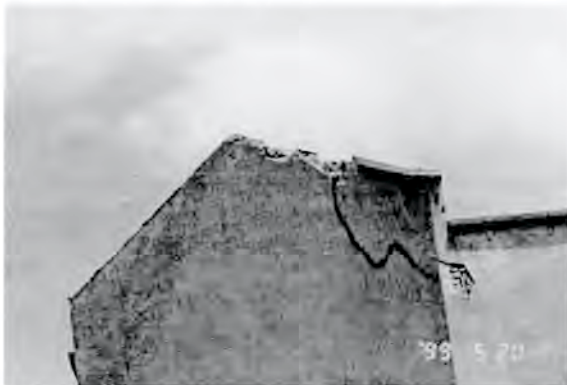
Facades built on the roofs of buildings are highly prone to be struck by lightning since they are normally built on the edge of the roof where the risk is high. Most of the stricken points seemed to be located at the highest point on the façades, the location that has the highest risk of being struck by lightning (Figure 6). Hence every façade should have an air terminal installed at its highest point.

Figure 6. A close-up photograph of a severely damaged façade of a commercial building. In this case, the stricken point appears to be on the slant side of the façade instead of on the pinnacle.

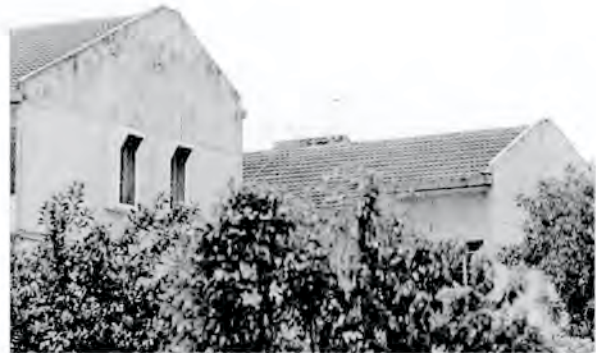
In a row of connected buildings, such as terraced low level apartments, homes and shops, it has been observed that the units at the ends of the row are more prone to be struck by lightning (Figure 7).

Most of the stricken points seemed to be located on the highest point of the last unit in the row.

Figure 7. Two adjacent residential apartments with similar stricken points on the roofs.

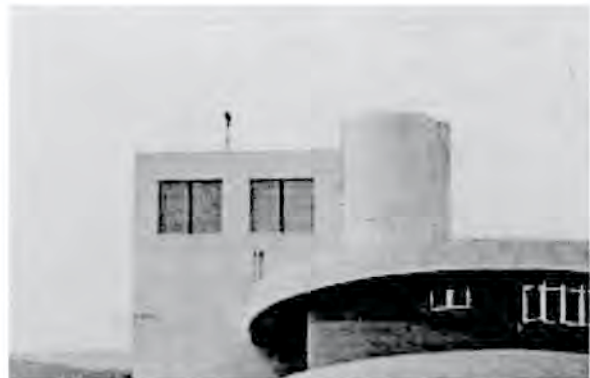
In the observed cases, the stricken point on the curved feature may be higher, on the same level as or lower than the sharp feature. Some of the stricken points have even been observed to be located close to and below an air terminal that operate on the basis of electric field enhancement.

Figure 8. A stricken point located on the curved portion of the roof (right) with an undamaged sharp corner nearby (left).

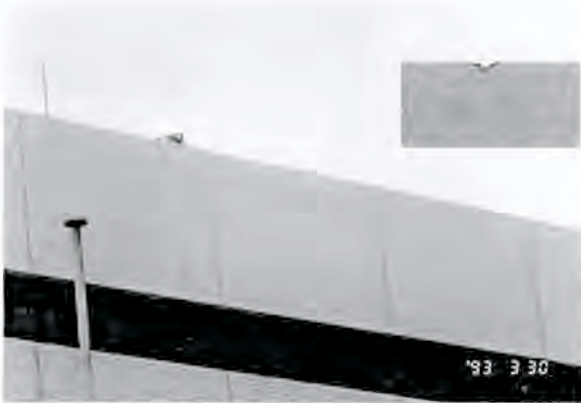
Figure 9. A stricken point on the straight edge of the roof (far right). Inset: A close up of the stricken point.

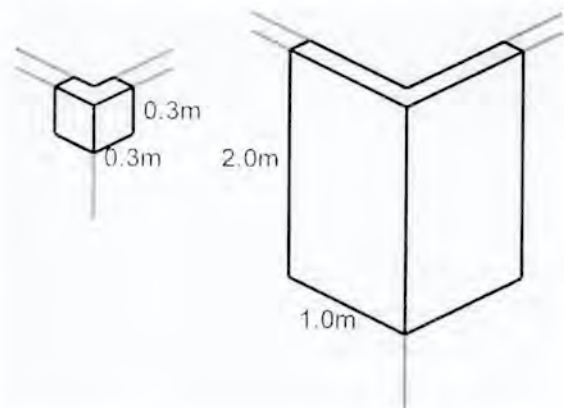
Figure 10. Recommended dimensions of the sheet metal caps for the protection of corner structures of low buildings (left) and tall buildings (right).

For small and low buildings, the recommended dimensions of these caps should extend at least 0.3m from the apex of the corners. These caps can then be grounded using down conductors or connected to the building reinforcement bars where applicable.

For very tall buildings (i.e. >60m), the recommended dimension of the caps to be installed at the extreme corners of the roof should be at least 1.0m for the horizontal dimensions and 2.0m for the vertical dimension (see Figure 10). This is to cater to the observed stricken points below the corner edges of tall buildings. The caps can then be grounded to the building reinforcement bars located near the corner of the buildings.

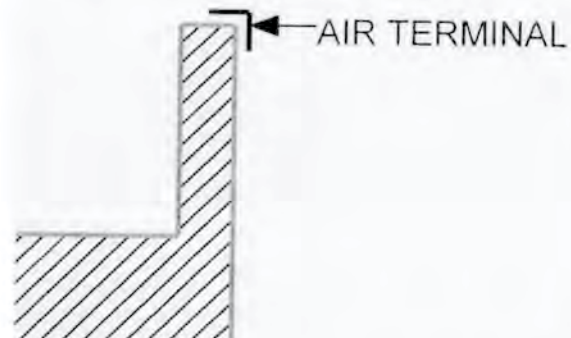
Figure 11. L-shape cross-section of air terminal for the protection of parapet walls and roof edges.

For the protection of the remaining parts of the roof, it is recommended that horizontal air terminations (i.e. copper strips or L-shape cross-sectioned metal panels) be

installed at the very edge of the roof or parapet wall and bonded to the metal panels at the corners (see example as shown in Figures 11 and 12). This is because most of the stricken points observed occur on the outer edges of the building.

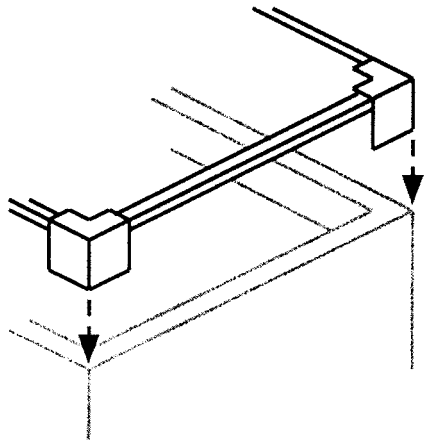
Figure 12. An example of parapet wall sheet metal caps used with L-shape cross-sectioned conductors to protect the building fabric from being struck by lightning.
