SEAWORLD ORLANDO LIGHTNING INCIDENT

**FAILURE OF THE SECOND GENERATION
EARLY STREAMER EMISSION LIGHTNING ROD**

**By
Z. A. Hartono & I Robiah
September 2012
E-mail: zahartono@ieee.org**

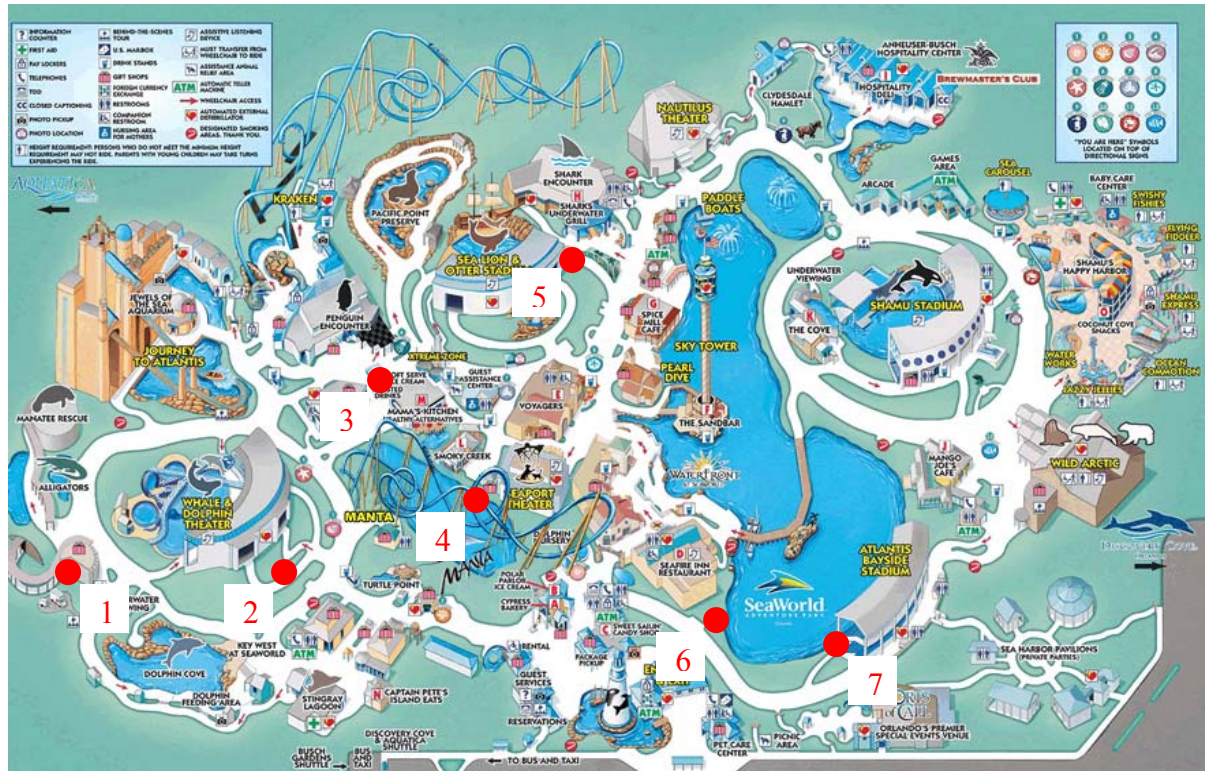
Fig. 1: The SeaWorld theme park with the location of the seven ESE lightning rods (red dots). (Map: Orlando Discount Tickets USA)
